**Flood Control Project Maintenance
Levee Inspections**
LMA District Cover Sheet
Spring 2016 Levee Inspection Results

American River Flood Control District

Spring 2016 Levee Inspection Results

Waterway			Bank	Unit Miles
Unit No. 01 Arcade Creek			Left	2.08
	Spring (March - May)	Summer (June - August)	(September - November) Fall	Winter (December - February)
Unit Maintenance Rating (Fall Only)				
Date of Inspection	3/2/2016 - 3/2/2016			
DWR Inspector	Maksim Khashchuk			
Accompanied By	Richard Marck ARFCD			
	Sterling York

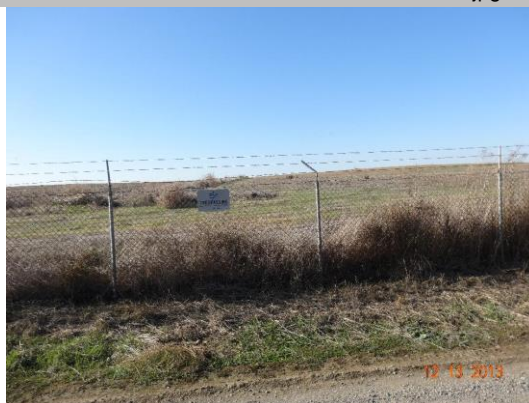
Photo 2 of 2 : UCIP_SP_2016_42128_56572.jpg

Comment Code					
Inspector Comment					
FS_ID:42128 DS_ID:24807 EP_NO: N/A Repair Type: Non-Urgent Crossing Status: Indicator Found UCIP Comments: 11/3/2014 (DWR-Olivia) Need to contact owner to determine status of crossing. Priority under Part IX has been changed from Urgent to Non-Urgent as a measure to normalize the data. Per Title 23 markers are necessary for pressure line--markers present. Recommend LMA to contact owner to determine additional information details--CVFPB permit, depth of pipe through levee, alignment, and last inspection completed confirming integrity of crossing.No permit found. Will need to contact owner to determine the status of crossing. FIELD_STRUCT_DESC: Petroleum pipeline through the levee, unknow depth. Markers visible on waterside (WS). Unable to confirm alignment. Kinder Morgan (Owner) contact information is 916-363-1666. FS Date: 12/13/2013

View of landward side.

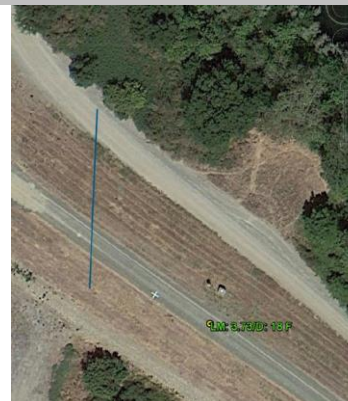
Photo 1 of 2 : UCIP_SP_2016_31255_57226.jpg

LM Start	3.75	Rating **	M	Issue No.	770
LM End	3.75	Issue Type +	En	Location *	LS
Category	Supplemental			GPS Latitude/Longitude	
				Start	End
Item	DWR UCIP Field Study			38.587724 °	38.587724 °
				-121.449554 °	-121.449554 °
DWR ID					
Comment Code					
Inspector Comment					
FS_ID:31255 DS_ID:24335 EP_NO: N/A Repair Type: Non-Urgent Crossing Status: Found UCIP Comments: Control box is non-functional parts have been removed. Unable to confirm diameter size and status--City of Sacramento incidates a 24 inch sewer main not 18 inch. Need to contact owner to confirm size. FIELD_STRUCT_DESC: 18-inch sewer main through the levee. Concrete manhole on the waterside (WS) slope. FS Date: 12/13/2013

Approximate alignment provided by City of Sacramento and DWR-UCIP confirmed location of sewer line is indicated by green label.

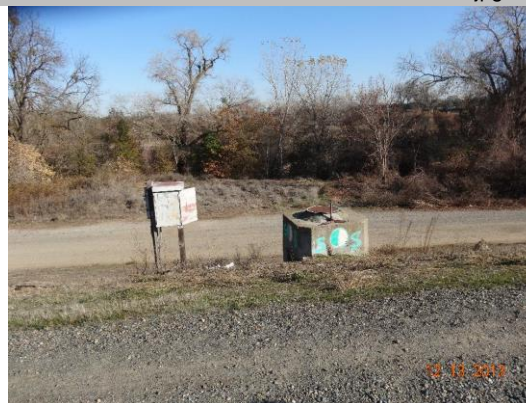
Photo 2 of 2 : UCIP_SP_2016_31255_57223.jpg

View of waterward side.

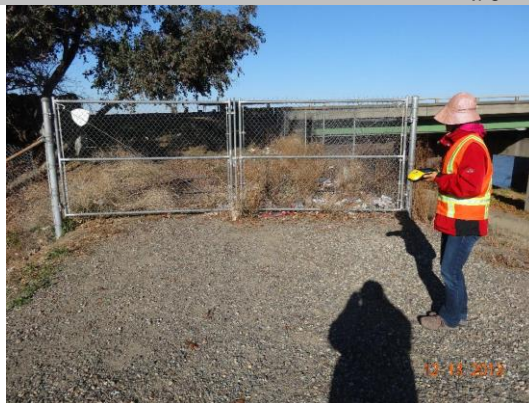
Photo 1 of 2 : UCIP_SP_2016_29954_55292.jpg

Comment Code					
Inspector Comment					
FS_ID:29954 DS_ID:24311 EP_NO: 2805 Repair Type: Urgent Crossing Status: Indicator Found UCIP Comments: bad odor (sewage smell) coming from this area -- potential leak. Unable to confirm if riser on landward side is part of crossing. FIELD_STRUCT_DESC: [Co Sanitation District No. 2 Pump Station] 18-inch concrete sewer main through the levee, 9.0 feet below the crown. Concrete cutoff wall around pipe under waterside (WS) shoulder. 2-inch air release valve located on landside (LS) slope. Sewage pumping plant on LS. Rock revetment on WS slope. Crossing continues under the channel and through the opposite levee. (Permit No. 2805-1961) FS Date: 12/13/2013

View of levee crown section near highway.

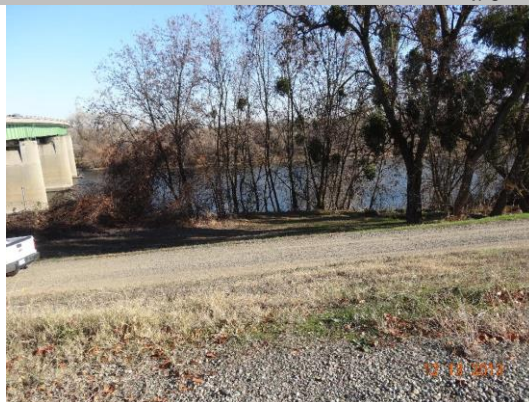
Photo 2 of 2 : UCIP_SP_2016_29954_55291.jpg

View of waterward side.

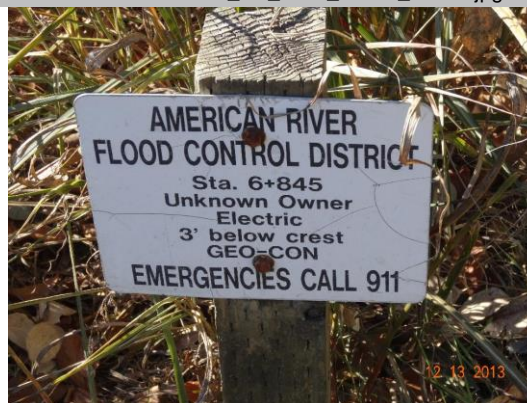
Photo 1 of 2 : UCIP_SP_2016_29054_53588.jpg

LM Start	3.89	Rating **	M	Issue No.	757
LM End	3.89	Issue Type +	En	Location *	LS
Category	Supplemental			GPS Latitude/Longitude	
				Start	End
Item	DWR UCIP Field Study			38.586479 °	38.586479 °
				-121.447574 °	-121.447574 °
DWR ID					
Comment Code					
Inspector Comment					
FS_ID:29054 DS_ID:24337 EP_NO: N/A Repair Type: Non-Urgent Crossing Status: Found UCIP Comments: Unknown owner--Need to coordinate with DWR Inspector and CVFPB. FIELD_STRUCT_DESC: 3-inch PVC conduit through levee, 2.0 feet below the crown. FS Date: 12/13/2013

Electrical conduit marker located on landward toe.

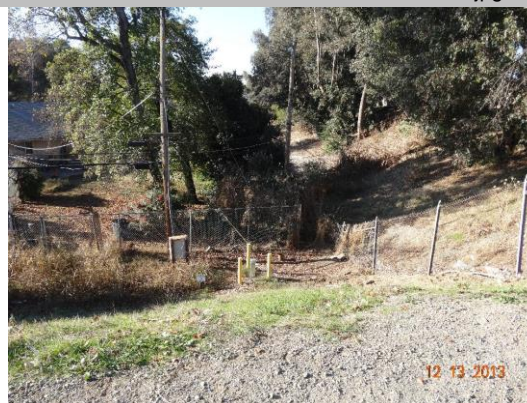
Photo 2 of 2 : UCIP_SP_2016_29054_53587.jpg

View of landward side.

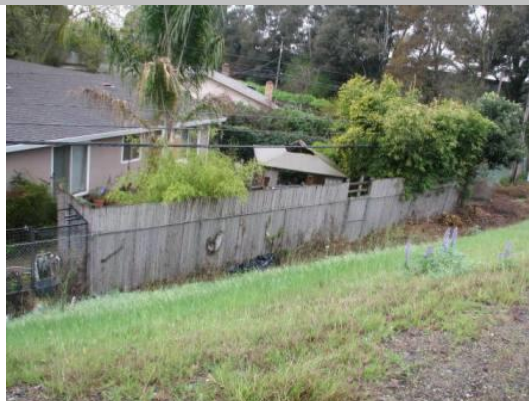
Photo 1 of 2 : SP_2016_NA0001_55_8_20160229_00009.jpg

03/16/2012 Wood privacy fence completely obstructs access and visibility.

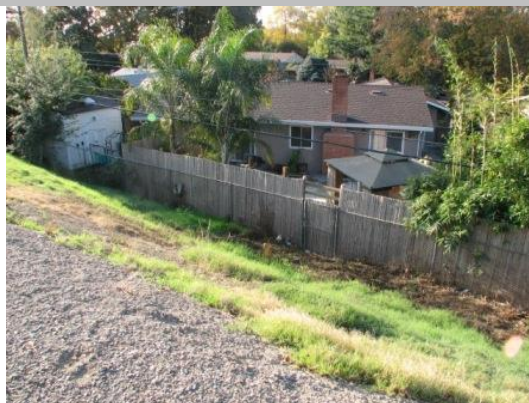
Photo 2 of 2 : SP_2016_NA0001_55_8_20160229_00010.jpg

Fall 2009 photo: Fence and landscaping within 10-ft of levee toe obstructs access and visibility.

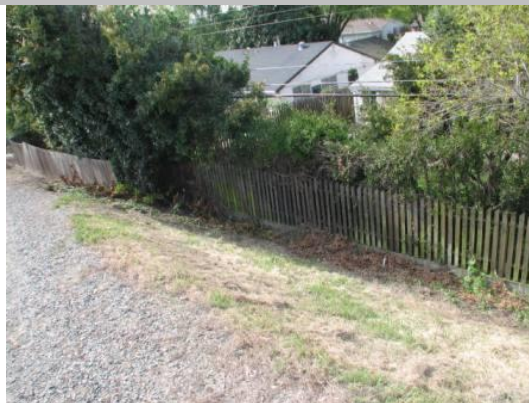
Photo 1 of 1 : SP_2016_NA0001_55_6_20160229_00007.jpg

LM Start	3.92	Rating **	U	Issue No.	6
LM End	3.92	Issue Type +	En	Location *	LS
Category	Earthen Levee			GPS Latitude/Longitude	
				Start	End
Item	Encroachments			38.586154 °	38.586154 °
				-121.447115 °	-121.447115 °
DWR ID	DWR_NA0001_04_s_2012_6				
Comment Code					
FE : Fence					
Inspector Comment					
Privacy fence within 10-ft of the landside toe obstructs visibility. 04/14/2011 Landscaping has been removed.

04/14/2011 Landscaping, which was a Fall inspection issue has been removed, however wooden fence is still obstructing access and visibility.

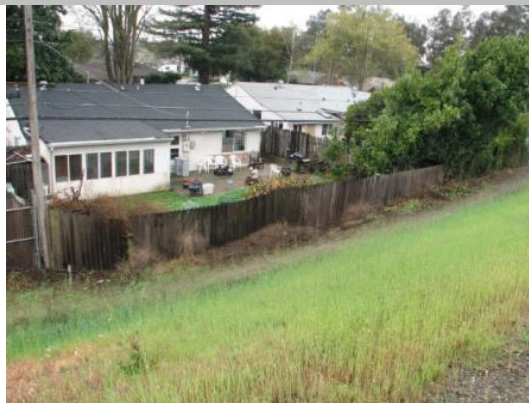
Photo 1 of 1 : SP_2016_NA0001_55_9_20160229_00011.jpg

LM Start	3.93	Rating **	U	Issue No.	9
LM End	3.93	Issue Type +	En	Location *	LS
Category	Earthen Levee			GPS Latitude/Longitude	
				Start	End
Item	Encroachments			38.586047 °	38.586047 °
				-121.446975 °	-121.446975 °
DWR ID	DWR_NA0001_04_s_2012_9				
Comment Code					
FE : Fence					
Inspector Comment					
Wooden privacy fence on the levee slope obstructs access and visibility.

03/16/2012 Wood privacy fence completely obstructs access and visibility.

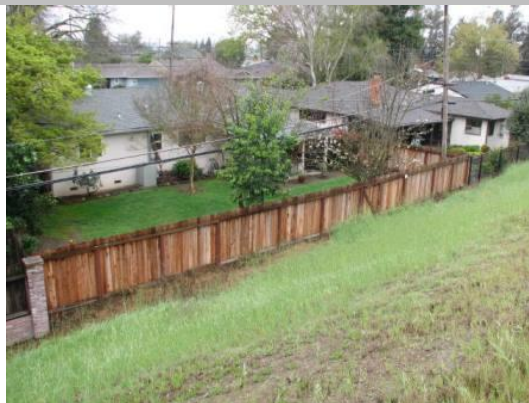
Photo 1 of 1 : SP_2016_NA0001_55_11_20160229_00012.jpg

LM Start	3.97	Rating **	U	Issue No.	11
LM End	3.97	Issue Type +	En	Location *	LS
Category	Earthen Levee			GPS Latitude/Longitude	
				Start	End
Item	Encroachments			38.585639 °	38.585639 °
				-121.446451 °	-121.446451 °
DWR ID	DWR_NA0001_04_s_2012_11				
Comment Code					
FE : Fence					
Inspector Comment					
Privacy fence and landscaping within 10-ft of the levee toe obstruct access and visibility.

03/16/2012 Wood privacy fence completely obstructs access and visibility.

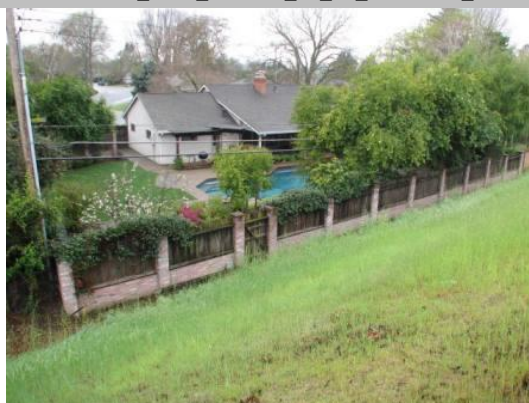
Photo 1 of 1 : SP_2016_NA0001_55_12_20160229_00013.jpg

LM Start	3.98	Rating **	U	Issue No.	12
LM End	3.98	Issue Type +	En	Location *	LS
Category	Earthen Levee			GPS Latitude/Longitude	
				Start	End
Item	Encroachments			38.585496 °	38.585496 °
				-121.446309 °	-121.446309 °
DWR ID	DWR_NA0001_04_s_2012_12				
Comment Code					
FE : Fence					
Inspector Comment					
Privacy fence and landscaping within 10-ft of the levee toe obstruct access and visibility.

03/16/2012 Wood privacy fence completely obstructs access and visibility.

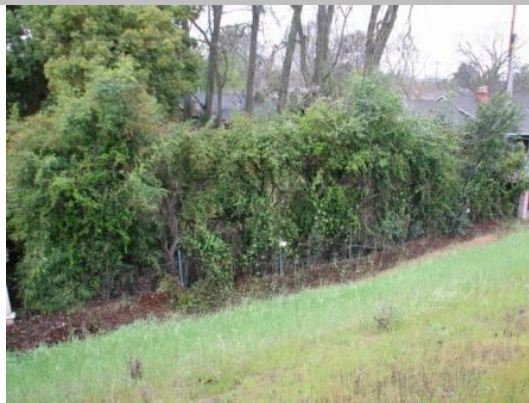
Photo 1 of 1 : SP_2016_NA0001_55_112_20160229_00096.jpg

LM Start	3.99	Rating **	U	Issue No.	112
LM End	3.99	Issue Type +	En	Location *	LS
Category	Earthen Levee			GPS Latitude/Longitude	
				Start	End
Item	Vegetation			38.585385 °	38.585385 °
				-121.446168 °	-121.446168 °
DWR ID	DWR_NA0001_04_s _ 2012_112				
Comment Code					
V6 : Landscaping					
Inspector Comment					
Landscaping completely blocks visibility.

03/16/2012 Landscape obstructs visibility and access.

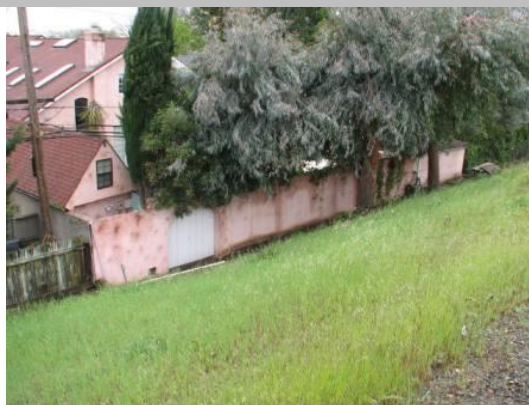
Photo 1 of 1 : SP_2016_NA0001_55_13_20160229_00014.jpg

LM Start	4.00	Rating **	U	Issue No.	13
LM End	4.00	Issue Type +	En	Location *	LS
Category	Earthen Levee			GPS Latitude/Longitude	
				Start	End
Item	Encroachments			38.585325 °	38.585325 °
				-121.446059 °	-121.446059 °
DWR ID	DWR_NA0001_04_s _ 2012_13				
Comment Code					
FE : Fence					
Inspector Comment					
Pink cement block fence obstructs access and visibility.

03/16/2012 Concrete wall obstructs access and visibility.

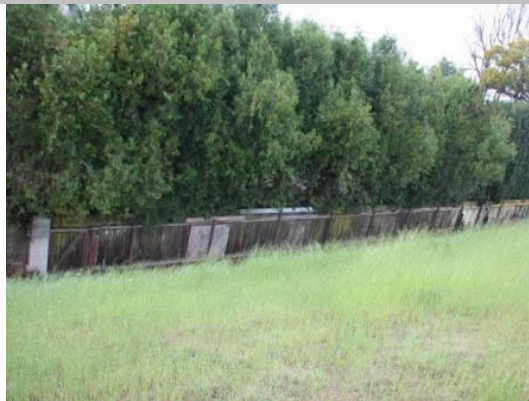
Photo 1 of 1 : SP_2016_NA0001_55_15_20160229_00016.jpg

LM Start	4.03	Rating **	U	Issue No.	15
LM End	4.03	Issue Type +	En	Location *	LS
Category	Earthen Levee			GPS Latitude/Longitude	
				Start	End
Item	Encroachments			38.585021 °	38.585021 °
				-121.445678 °	-121.445678 °
DWR ID	DWR_NA0001_04_s_2012_15				
Comment Code					
FE : Fence					
Inspector Comment					
Privacy fence and evergreen shrub landscaping within 10-ft of the levee toe obstruct access and visibility.

03/16/2012 Wood privacy fence completely obstructs access and visibility.

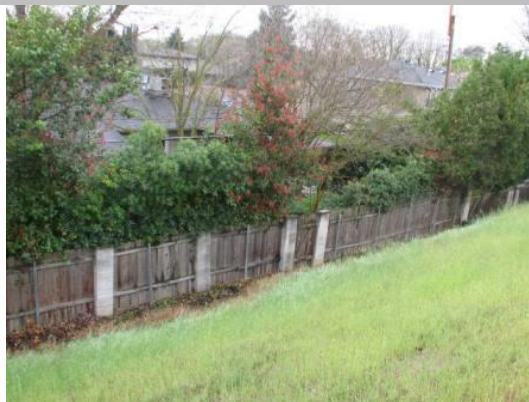
Photo 1 of 1 : SP_2016_NA0001_55_16_20160229_00017.jpg

LM Start	4.04	Rating **	U	Issue No.	16
LM End	4.04	Issue Type +	En	Location *	LS
Category	Earthen Levee			GPS Latitude/Longitude	
				Start	End
Item	Encroachments			38.584885 °	38.584885 °
				-121.445520 °	-121.445520 °
DWR ID	DWR_NA0001_04_s_2012_16				
Comment Code					
FE : Fence					
Inspector Comment					
Privacy fence and landscaping within 10-ft of the levee toe obstruct access and visibility.

03/16/2012 Wood privacy fence completely obstructs access and visibility.

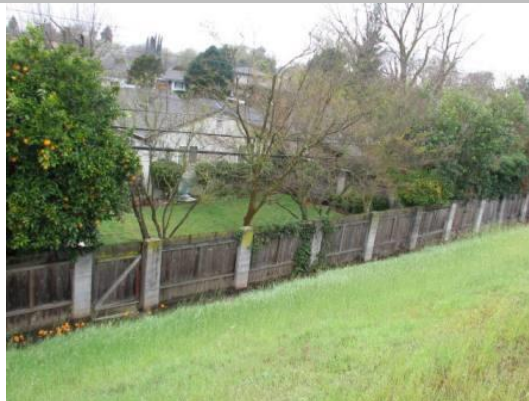
Photo 1 of 1 : SP_2016_NA0001_55_17_20160229_00018.jpg

LM Start	4.05	Rating **	U	Issue No.	17
LM End	4.05	Issue Type +	En	Location *	LS
Category	Earthen Levee			GPS Latitude/Longitude	
				Start	End
Item	Encroachments			38.584810 °	38.584810 °
				-121.445403 °	-121.445403 °
DWR ID	DWR_NA0001_04_s_2012_17				
Comment Code					
FE : Fence					
Inspector Comment					
Privacy fence and maple tree landscaping within 10-ft of the levee toe obstruct access and visibility.

03/16/2012 Wood privacy fence completely obstructs access and visibility.

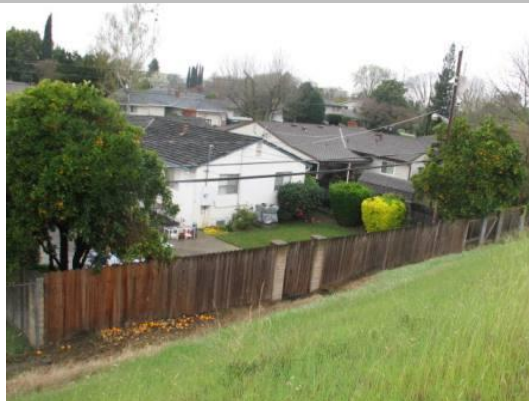
Photo 1 of 1 : SP_2016_NA0001_55_18_20160229_00019.jpg

LM Start	4.06	Rating **	U	Issue No.	18
LM End	4.06	Issue Type +	En	Location *	LS
Category	Earthen Levee			GPS Latitude/Longitude	
				Start	End
Item	Encroachments			38.584694 °	38.584694 °
				-121.445255 °	-121.445255 °
DWR ID	DWR_NA0001_04_s_2012_18				
Comment Code					
FE : Fence					
Inspector Comment					
Wooden fence between orange trees is within 10-ft of the levee toe.

03/16/2012 Wood privacy fence completely obstructs access and visibility.

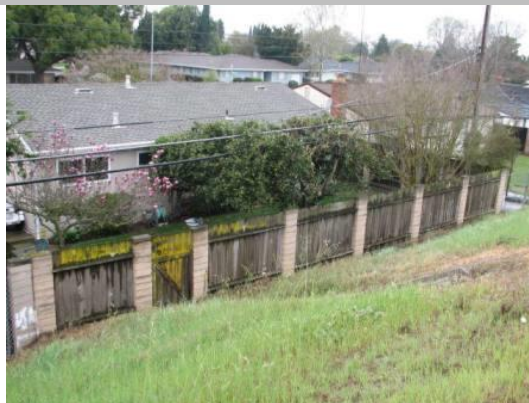
Photo 1 of 1 : SP_2016_NA0001_55_19_20160229_00020.jpg

LM Start	4.09	Rating **	U	Issue No.	19
LM End	4.09	Issue Type +	En	Location *	LS
Category	Earthen Levee			GPS Latitude/Longitude	
				Start	End
Item	Encroachments			38.584459 °	38.584459 °
				-121.444951 °	-121.444951 °
DWR ID	DWR_NA0001_04_s_2012_19				
Comment Code					
FE : Fence					
Inspector Comment					
Privacy fence within 10-ft of the levee toe obstruct access and visibility.

03/16/2012 Wood privacy fence completely obstructs access and visibility.

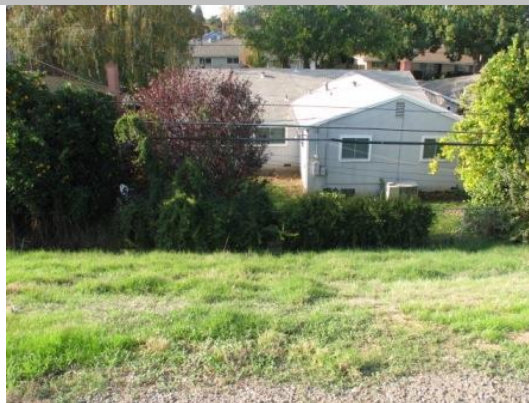
Photo 1 of 1 : SP_2016_NA0001_55_186_20160229_00160.jpg

LM Start	4.10	Rating **	M	Issue No.	186
LM End	4.10	Issue Type +	En	Location *	LS
Category	Earthen Levee			GPS Latitude/Longitude	
				Start	End
Item	Vegetation			38.584354 °	38.584354 °
				-121.444792 °	-121.444792 °
DWR ID	DWR_NA0001_04_s_2012_186				
Comment Code					
V6 : Landscaping					
Inspector Comment					
Landscaping on cyclone fence within 10-ft of levee toe obstructs access and visibility.

Fall 2009 photo: Landscaping within 10-ft of levee toe obstructs access and visibility.

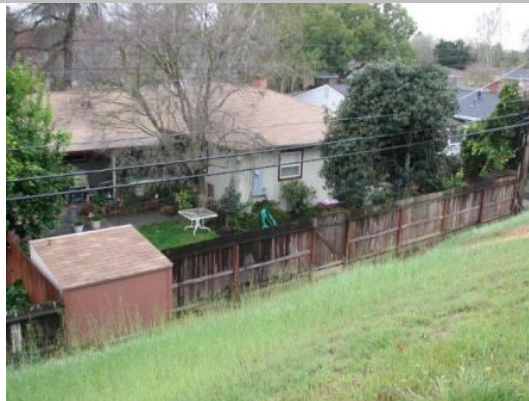
Photo 1 of 1 : SP_2016_NA0001_55_20_20160229_00021.jpg

LM Start	4.11	Rating **	U	Issue No.	20
LM End	4.11	Issue Type +	En	Location *	LS
Category	Earthen Levee			GPS Latitude/Longitude	
				Start	End
Item	Encroachments			38.584243 °	38.584243 °
				-121.444647 °	-121.444647 °
DWR ID	DWR_NA0001_04_s_2012_20				
Comment Code					
FE : Fence					
Inspector Comment					
Privacy fence and shed within 10-ft of the levee toe obstruct access and visibility.

03/16/2012 Wood privacy fence completely obstructs access and visibility.

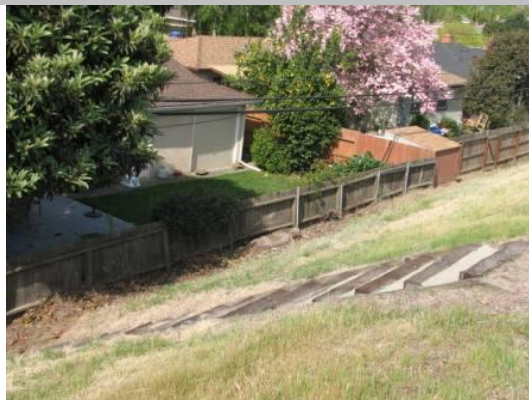
Photo 1 of 1 : SP_2016_NA0001_55_21_20160229_00022.jpg

LM Start	4.12	Rating **	U	Issue No.	21
LM End	4.12	Issue Type +	En	Location *	LS
Category	Earthen Levee			GPS Latitude/Longitude	
				Start	End
Item	Vegetation			38.584129 °	38.584129 °
				-121.444485 °	-121.444485 °
DWR ID	DWR_NA0001_04_s_2012_21				
Comment Code					
V6 : Landscaping					
Inspector Comment					
Palms and other landscaping on levee slope, as well as the wooden privacy fence within 10-ft of the levee toe obstruct access and visibility. 04/14/2011 Palms have been removed.

04/14/2011 Palms have been removed.

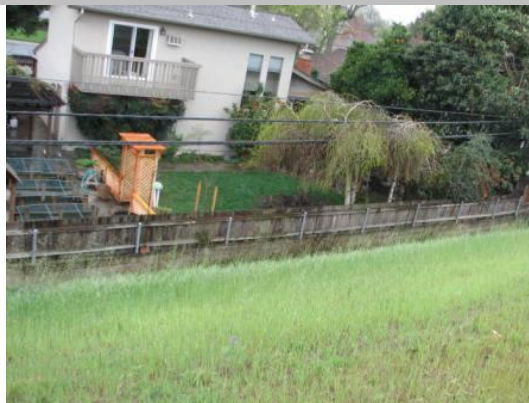
Photo 1 of 1 : SP_2016_NA0001_55_22_20160229_00023.jpg

LM Start	4.13	Rating **	U	Issue No.	22
LM End	4.13	Issue Type +	En	Location *	LS
Category	Earthen Levee			GPS Latitude/Longitude	
				Start	End
Item	Encroachments			38.584034 °	38.584034 °
				-121.444322 °	-121.444322 °
DWR ID	DWR_NA0001_04_s_2012_22				
Comment Code					
FE : Fence					
Inspector Comment					
Cement block and wooden fence as well as the landscape planting are within 10-ft of the levee slope and obstruct access and visibility.

03/16/2012 Wood privacy fence completely obstructs access and visibility.

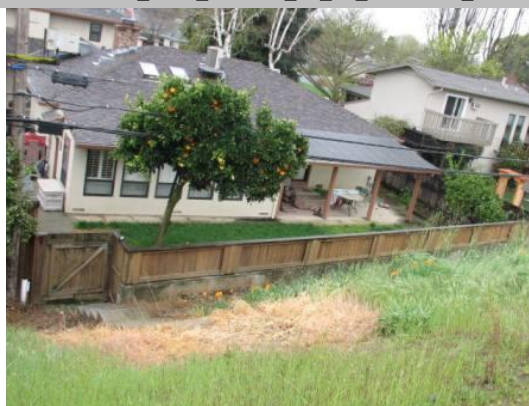
Photo 1 of 1 : SP_2016_NA0001_55_23_20160229_00024.jpg

LM Start	4.14	Rating **	U	Issue No.	23
LM End	4.14	Issue Type +	En	Location *	LS
Category	Earthen Levee			GPS Latitude/Longitude	
				Start	End
Item	Encroachments			38.583935 °	38.583935 °
				-121.444150 °	-121.444150 °
DWR ID	DWR_NA0001_04_s_2012_23				
Comment Code					
FE : Fence					
Inspector Comment					
Cement block and wooden fence obstruct visibility.

03/16/2012 Wooden fence on cement wall obstructs access and visibility.

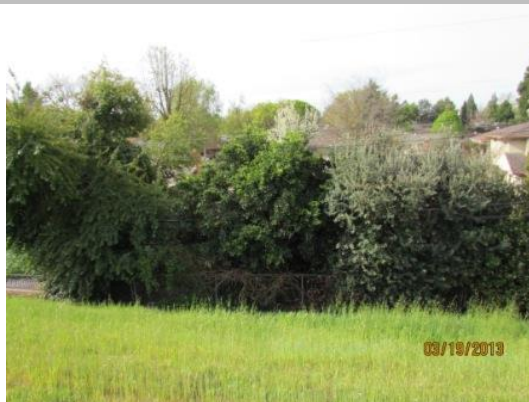
Photo 1 of 1 : SP_2016_NA0001_55_187_20160229_00161.jpg

LM Start	4.15	Rating **	M	Issue No.	187
LM End	4.15	Issue Type +	En	Location *	LS
Category	Earthen Levee			GPS Latitude/Longitude	
				Start	End
Item	Vegetation			38.583858 °	38.583858 °
				-121.443981 °	-121.443981 °
DWR ID	DWR_NA0001_04_s_2012_187				
Comment Code					
V6 : Landscaping					
Inspector Comment					
Orange, guava and other trees and landscaping obstruct access and visibility.

View of the obstructing vegetation at levee toe.

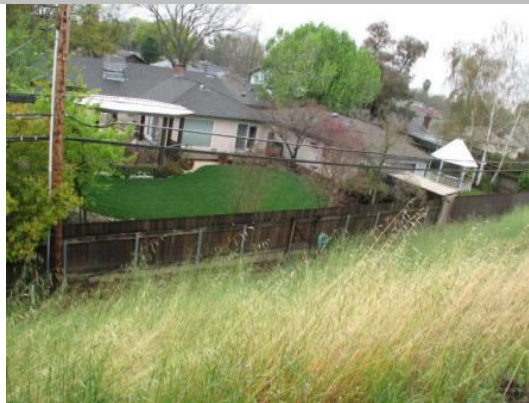
Photo 1 of 1 : SP_2016_NA0001_55_191_20160229_00163.jpg

LM Start	4.21	Rating **	U	Issue No.	191
LM End	4.21	Issue Type +	En	Location *	LS
Category	Earthen Levee			GPS Latitude/Longitude	
				Start	End
Item	Encroachments			38.583355 °	38.583355 °
				-121.443123 °	-121.443123 °
DWR ID	DWR_NA0001_04_s _ 2012_191				
Comment Code					
FE : Fence					
Inspector Comment					
Wooden privacy fence within 10-ft of the levee toe obstruct access and visibility.

03/16/2012 Wood privacy fence completely obstructs access and visibility.

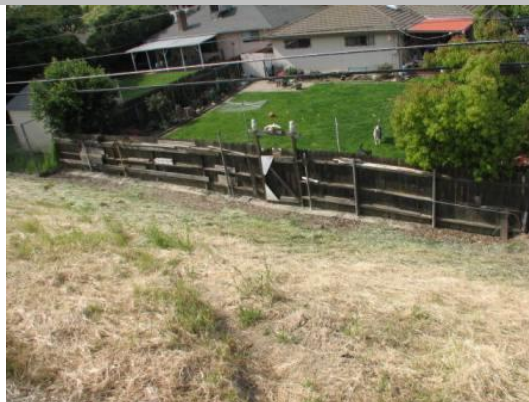
Photo 1 of 1 : SP_2016_NA0001_55_24_20160229_00025.jpg

LM Start	4.22	Rating **	U	Issue No.	24
LM End	4.22	Issue Type +	En	Location *	LS
Category	Earthen Levee			GPS Latitude/Longitude	
				Start	End
Item	Encroachments			38.583265 °	38.583265 °
				-121.442965 °	-121.442965 °
DWR ID	DWR_NA0001_04_s _ 2012_24				
Comment Code					
FE : Fence					
Inspector Comment					
Wooden privacy fence obstructs visibility. Retaining wall built into levee toe. 04/14/2011 retaining wall removed.

04/14/2011 Retaining wall has been removed. Wooden fence remains and is obstructing access and visibility.

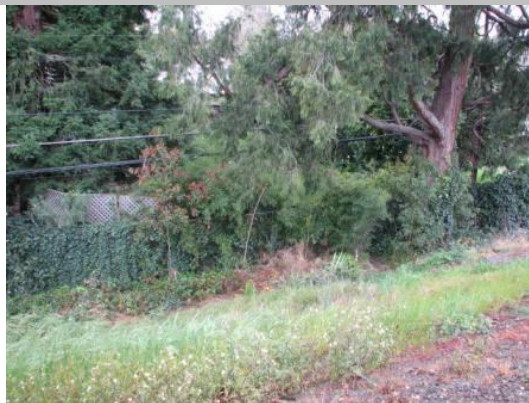
Photo 1 of 1 : SP_2016_NA0001_55_192_20160229_00164.jpg

LM Start	4.25	Rating **	U	Issue No.	192
LM End	4.25	Issue Type +	En	Location *	LS
Category	Earthen Levee			GPS Latitude/Longitude	
				Start	End
Item	Vegetation			38.583031 °	38.583031 °
				-121.442620 °	-121.442620 °
DWR ID	DWR_NA0001_04_s _ 2012_192				
Comment Code					
V6 : Landscaping					
Inspector Comment					
Ivy and vine growth on cyclone fence obstruct visibility. Steps and landscaping built up levee slope.

03/16/2012 Landscaping on fence obstructs visibility and access.

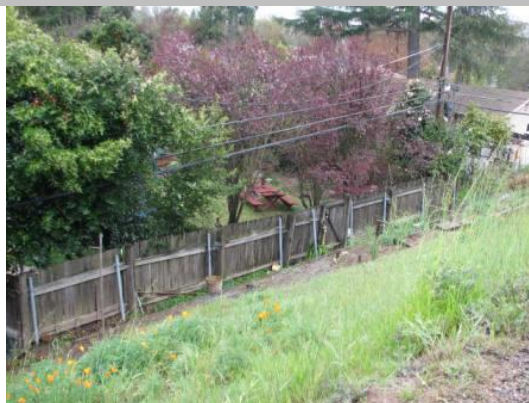
Photo 1 of 1 : SP_2016_NA0001_55_26_20160229_00026.jpg

LM Start	4.31	Rating **	U	Issue No.	26
LM End	4.31	Issue Type +	En	Location *	LS
Category	Earthen Levee			GPS Latitude/Longitude	
				Start	End
Item	Encroachments			38.582479 °	38.582479 °
				-121.441768 °	-121.441768 °
DWR ID	DWR_NA0001_04_s_2012_26				
Comment Code					
FE : Fence					
Inspector Comment					
Wooden fence within 10-ft of the levee toe. Garden and ramp built on levee slope.

03/16/2012 Wood privacy fence completely obstructs access and visibility.

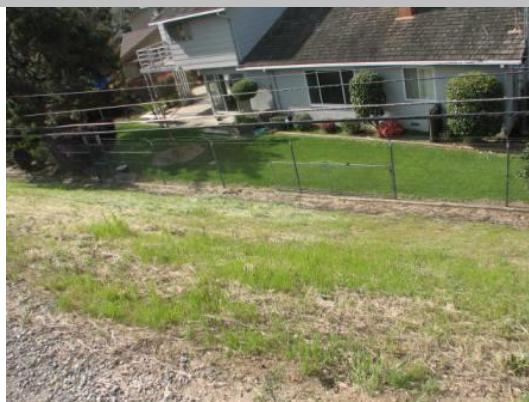
Photo 1 of 1 : SP_2016_NA0001_55_195_20160229_00166.jpg

LM Start	4.32	Rating **	M	Issue No.	195
LM End	4.32	Issue Type +	En	Location *	LS
Category	Earthen Levee			GPS Latitude/Longitude	
				Start	End
Item	Encroachments			38.582333 °	38.582333 °
				-121.441506 °	-121.441506 °
DWR ID	DWR_NA0001_04_s_2012_195				
Comment Code					
FE : Fence					
Inspector Comment					
Landscaping planted on levee slope. 04/14/2011 Landscaping removed, chainlink fence remains.

04/14/2011 Landscape removed, chainlink fence remains.

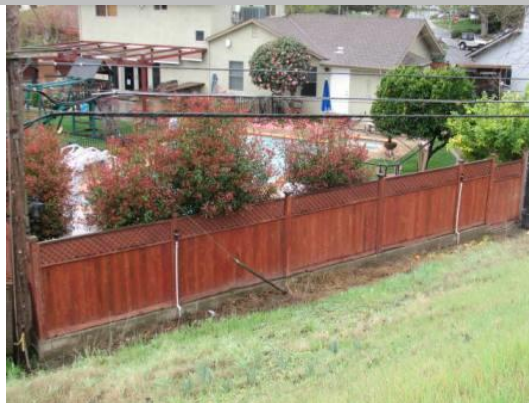
Photo 1 of 1 : SP_2016_NA0001_55_27_20160229_00027.jpg

LM Start	4.34	Rating **	U	Issue No.	27
LM End	4.34	Issue Type +	En	Location *	LS
Category	Earthen Levee			GPS Latitude/Longitude	
				Start	End
Item	Encroachments			38.582223 °	38.582223 °
				-121.441264 °	-121.441264 °
DWR ID	DWR_NA0001_04_s _ 2012_27				
Comment Code					
FE : Fence					
Inspector Comment					
Wooden privacy fence obstructs visibility.

03/16/2012 Wood privacy fence completely obstructs access and visibility.

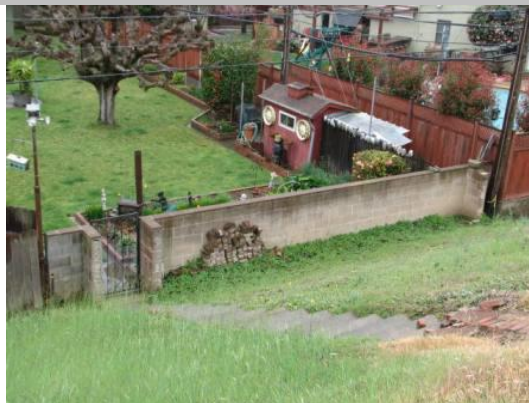
Photo 1 of 1 : SP_2016_NA0001_55_28_20160229_00028.jpg

LM Start	4.35	Rating **	U	Issue No.	28
LM End	4.35	Issue Type +	En	Location *	LS
Category	Earthen Levee			GPS Latitude/Longitude	
				Start	End
Item	Encroachments			38.582186 °	38.582186 °
				-121.441160 °	-121.441160 °
DWR ID	DWR_NA0001_04_s _ 2012_28				
Comment Code					
FE : Fence					
Inspector Comment					
Cement block fence obstructs access and visibility.

03/16/2012 Cinder block wall obstructs visibility and access.

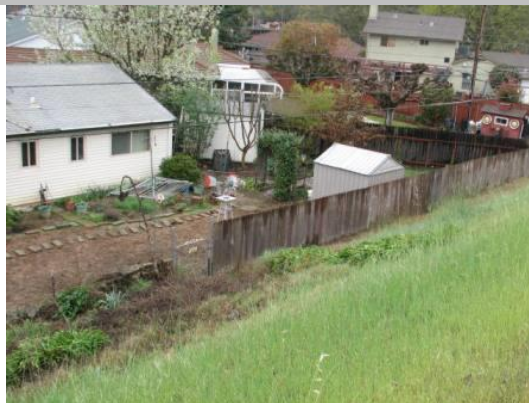
Photo 1 of 1 : SP_2016_NA0001_55_29_20160229_00029.jpg

LM Start	4.36	Rating **	M	Issue No.	29
LM End	4.36	Issue Type +	En	Location *	LS
Category	Earthen Levee			GPS Latitude/Longitude	
				Start	End
Item	Encroachments			38.582083 °	38.582083 °
				-121.440875 °	-121.440875 °
DWR ID	DWR_NA0001_04_s _ 2012_29				
Comment Code					
FE : Fence					
Inspector Comment					
Large flowering bush on levee slope - removed by ARFCD 2012. Retaining wall removed by ARFCD 2012. Wooden fence located at the levee toe obstructs access and visibility. 04/14/2011

03/16/2012 Flowering bush is dormant, landscaping on levee slope and wooden privacy fence.

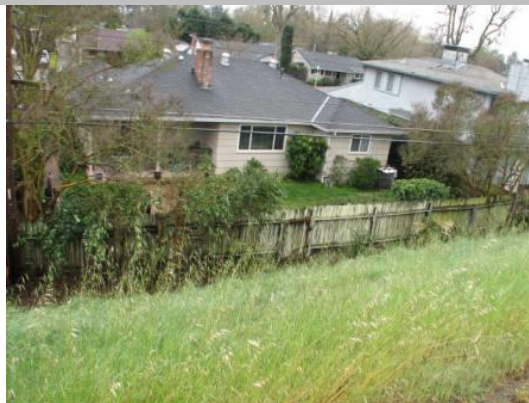
Photo 1 of 1 : SP_2016_NA0001_55_198_20160229_00168.jpg

LM Start	4.41	Rating **	U	Issue No.	198
LM End	4.41	Issue Type +	En	Location *	LS
Category	Earthen Levee			GPS Latitude/Longitude	
				Start	End
Item	Encroachments			38.581788 °	38.581788 °
				-121.440086 °	-121.440086 °
DWR ID	DWR_NA0001_04_s _ 2012_198				
Comment Code					
FE : Fence					
Inspector Comment					
Privacy fence and landscaping within 10-ft of the levee toe obstruct access and visibility.

03/16/2012 Wood privacy fence completely obstructs access and visibility.

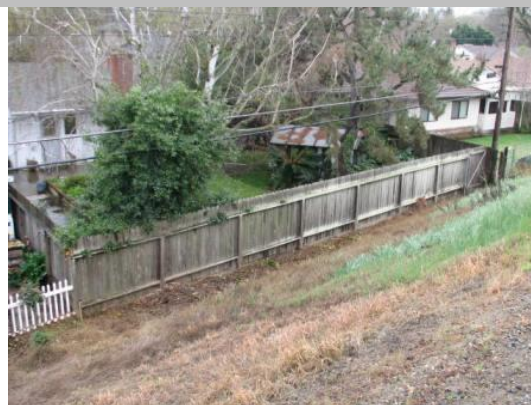
Photo 1 of 1 : SP_2016_NA0001_55_31_20160229_00031.jpg

LM Start	4.47	Rating **	U	Issue No.	31
LM End	4.47	Issue Type +	En	Location *	LS
Category	Earthen Levee			GPS Latitude/Longitude	
				Start	End
Item	Encroachments			38.581495 °	38.581495 °
				-121.439129 °	-121.439129 °
DWR ID	DWR_NA0001_04_s _ 2012_31				
Comment Code					
FE : Fence					
Inspector Comment					
Privacy fence within 10-ft of the levee toe obstructs access and visibility.

03/16/2012 Wood privacy fence completely obstructs access and visibility.

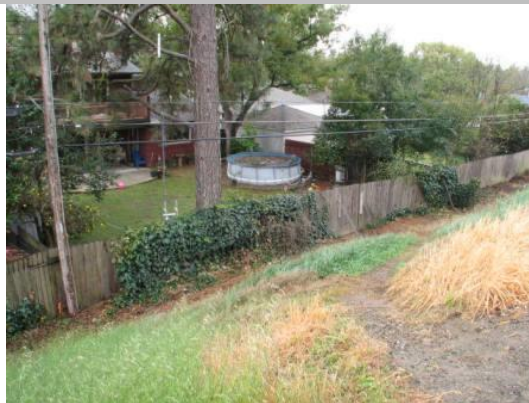
Photo 1 of 1 : SP_2016_NA0001_55_199_20160229_00169.jpg

LM Start	4.54	Rating **	U	Issue No.	199
LM End	4.54	Issue Type +	En	Location *	LS
Category	Earthen Levee			GPS Latitude/Longitude	
				Start	End
Item	Encroachments			38.581205 °	38.581205 °
				-121.437830 °	-121.437830 °
DWR ID	DWR_NA0001_04_s _ 2012_199				
Comment Code					
FE : Fence					
Inspector Comment					
Wooden fence is within 10-ft of the levee toe.

03/16/2012 Wood privacy fence completely obstructs access and visibility.

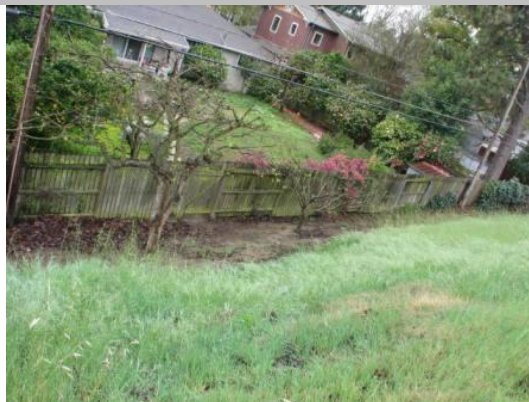
Photo 1 of 1 : SP_2016_NA0001_55_200_20160229_00170.jpg

LM Start	4.55	Rating **	U	Issue No.	200
LM End	4.55	Issue Type +	En	Location *	LS
Category	Earthen Levee			GPS Latitude/Longitude	
				Start	End
Item	Encroachments			38.581178 °	38.581178 °
				-121.437584 °	-121.437584 °
DWR ID	DWR_NA0001_04_s _ 2012_200				
Comment Code					
FE : Fence					
Inspector Comment					
Privacy fence, persimmon tree and landscaping within 10-ft of the levee toe obstruct access and visibility.

03/16/2012 Wood privacy fence completely obstructs access and visibility.

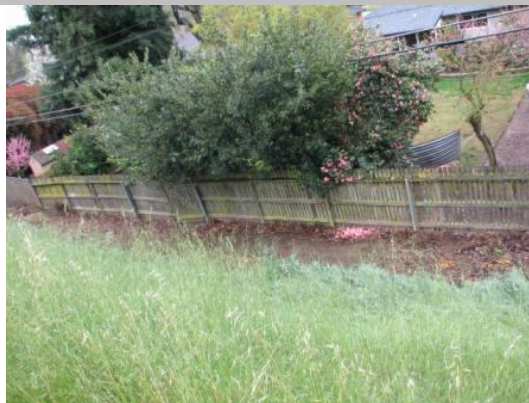
Photo 1 of 1 : SP_2016_NA0001_55_201_20160229_00171.jpg

LM Start	4.57	Rating **	U	Issue No.	201
LM End	4.57	Issue Type +	En	Location *	LS
Category	Earthen Levee			GPS Latitude/Longitude	
				Start	End
Item	Encroachments			38.581155 °	38.581155 °
				-121.437320 °	-121.437320 °
DWR ID	DWR_NA0001_04_s _ 2012_201				
Comment Code					
FE : Fence					
Inspector Comment					
Privacy fence within 10-ft of the levee toe obstruct access and visibility.

03/16/2012 Wood privacy fence completely obstructs access and visibility.

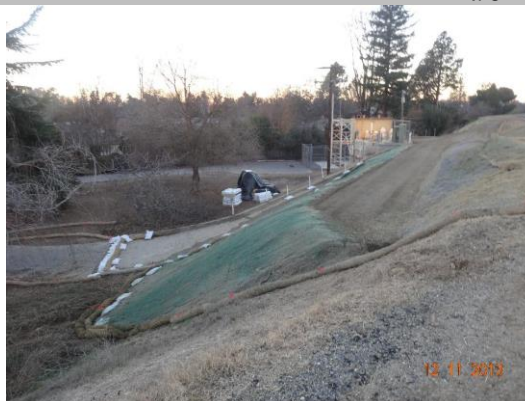
Photo 1 of 2 : UCIP_SP_2016_31446_57490.jpg

LM Start	4.61	Rating **	M	Issue No.	763
LM End	4.61	Issue Type +	En	Location *	LS
Category	Supplemental			GPS Latitude/Longitude	
				Start	End
Item	DWR UCIP Field Study			38.581101 °	38.581101 °
				-121.436502 °	-121.436502 °
DWR ID					
Comment Code					
Inspector Comment					
FS_ID:31446					
DS_ID:24808					
EP_NO: N/A					
Repair Type: Non-Urgent					
Crossing Status: Indicator Found					
UCIP Comments: New construction--need permit and details on crossing.					
FIELD_STRUCT_DESC: 1 of 4: Concrete service box located on waterside (WS) shoulder. Landside (LS) has been regraded. No permit was found for the work. Unable to verify if crossing crosses levee.					
FS Date: 12/13/2013

View of landward side.

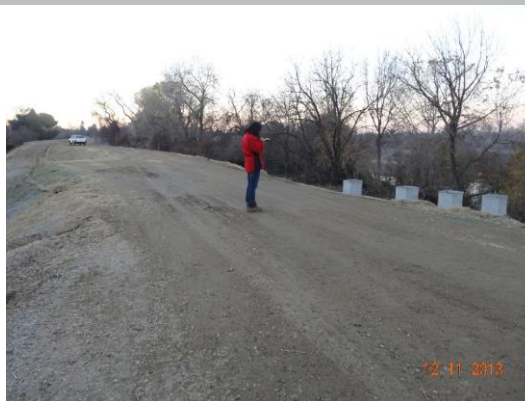
Photo 2 of 2 : UCIP_SP_2016_31446_57489.jpg

View of regraded levee crown with service boxes on waterward slope.

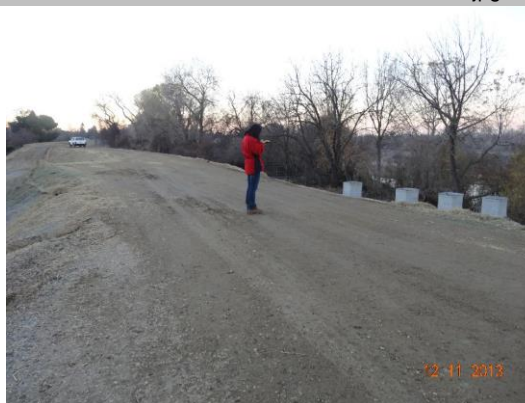
Photo 2 of 2 : UCIP_SP_2016_31447_57492.jpg

LM Start	4.61	Rating **	M	Issue No.	764
LM End	4.61	Issue Type +	En	Location *	LS
Category	Supplemental			GPS Latitude/Longitude	
				Start	End
Item	DWR UCIP Field Study			38.581092 °	38.581092 °
				-121.436466 °	-121.436466 °
DWR ID					
Comment Code					
Inspector Comment					
FS_ID:31447					
DS_ID:24809					
EP_NO: N/A					
Repair Type: Non-Urgent					
Crossing Status: Indicator Found					
UCIP Comments: New construction; no permit found; Need additional information about crossings to determine whether crossings penetrate levee.					
FIELD_STRUCT_DESC: 2 of 4: Concrete service box located on waterside (WS) shoulder. Landside (LS) has been regraded. No permit was found for the work. Unable to verify if crossing crosses levee.					
FS Date: 12/13/2013

View of levee crown at crossings.

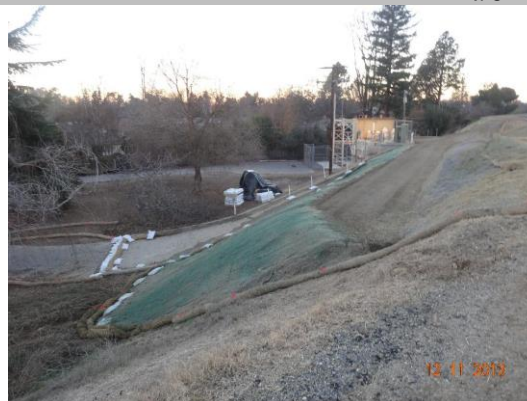
Photo 1 of 2 : UCIP_SP_2016_31448_57496.jpg

LM Start	4.61	Rating **	M	Issue No.	765
LM End	4.61	Issue Type +	En	Location *	LS
Category	Supplemental			GPS Latitude/Longitude	
				Start	End
Item	DWR UCIP Field Study			38.581087°	38.581087°
				-121.436449°	-121.436449°
DWR ID					
Comment Code					
Inspector Comment					
FS_ID:31448					
DS_ID:24810					
EP_NO: N/A					
Repair Type: Non-Urgent					
Crossing Status: Indicator Found					
UCIP Comments: New construction; no permit found; Need additional information about crossings to determine whether crossings penetrate levee.					
FIELD_STRUCT_DESC: 3 of 4: Concrete service box located on waterside (WS) shoulder. Landside (LS) has been regraded. No permit was found for the work. Unable to verify if crossing crosses levee.					
FS Date: 12/13/2013

View of landward side.

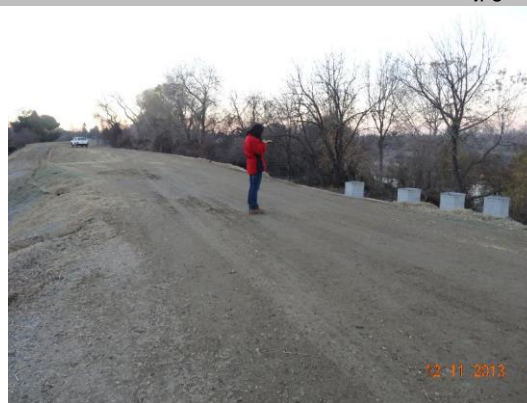
Photo 2 of 2 : UCIP_SP_2016_31448_57495.jpg

View of levee crown.

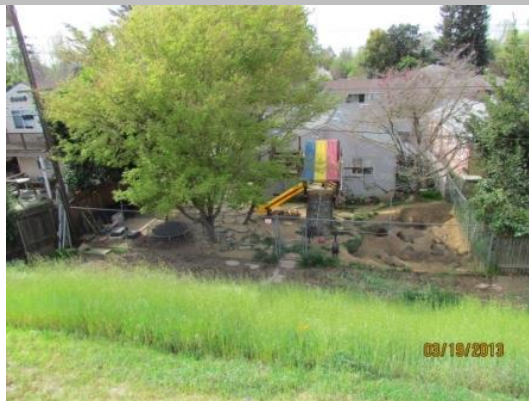
Photo 1 of 2 : SP_2016_NA0001_55_739_20160229_00190.jpg

LM Start	4.72	Rating **	M	Issue No.	739
LM End	4.72	Issue Type +	En	Location *	LS
Category	Earthen Levee			GPS Latitude/Longitude	
				Start	End
Item	Encroachments			38.580778 °	38.580778 °
				-121.434467 °	-121.434467 °
DWR ID	DWR_NA0001_04_s _ 2012_739				
Comment Code					
DE : Debris					
Inspector Comment					
PVC pipe and debris, also noted in USACE PI.

View of the previously noted debris stored in the upstream corner of the property. Note extensive burrowing in the backyard on the downstream (right) corner of the property.

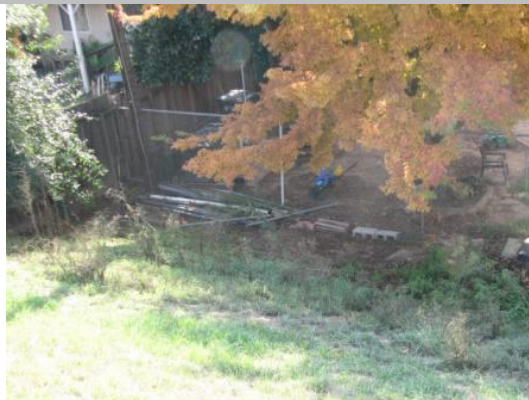
Photo 2 of 2 : SP_2016_NA0001_55_739_20160229_00191.jpg

11/15/2011 Debris on levee side of fence. This item was noted in the USACE PI.

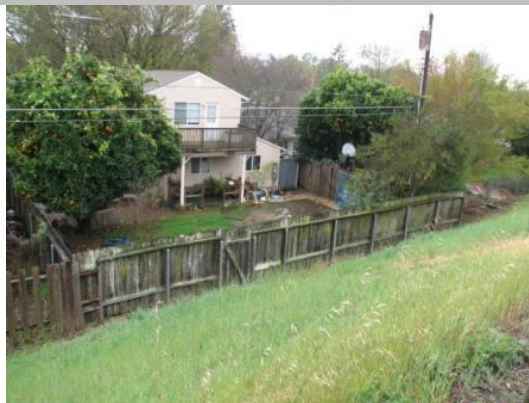
Photo 1 of 1 : SP_2016_NA0001_55_40_20160229_00033.jpg

LM Start	4.73	Rating **	U	Issue No.	40
LM End	4.73	Issue Type +	En	Location *	LS
Category	Earthen Levee			GPS Latitude/Longitude	
				Start	End
Item	Encroachments			38.580759 °	38.580759 °
				-121.434294 °	-121.434294 °
DWR ID	DWR_NA0001_04_s _ 2012_40				
Comment Code					
FE : Fence					
Inspector Comment					
Privacy fence within 10-ft of the levee toe obstruct access and visibility.

03/16/2012 Wood privacy fence completely obstructs access and visibility.

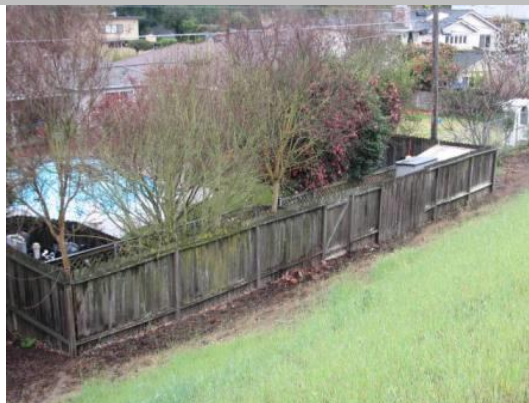
Photo 1 of 1 : SP_2016_NA0001_55_43_20160229_00035.jpg

LM Start	4.78	Rating **	U	Issue No.	43
LM End	4.78	Issue Type +	En	Location *	LS
Category	Earthen Levee			GPS Latitude/Longitude	
				Start	End
Item	Encroachments			38.580731 °	38.580731 °
				-121.433490 °	-121.433490 °
DWR ID	DWR_NA0001_04_s_2012_43				
Comment Code					
FE : Fence					
Inspector Comment					
Privacy fence and storage sheds within 10-ft of the levee toe obstruct access and visibility.

03/16/2012 Wood privacy fence completely obstructs access and visibility.

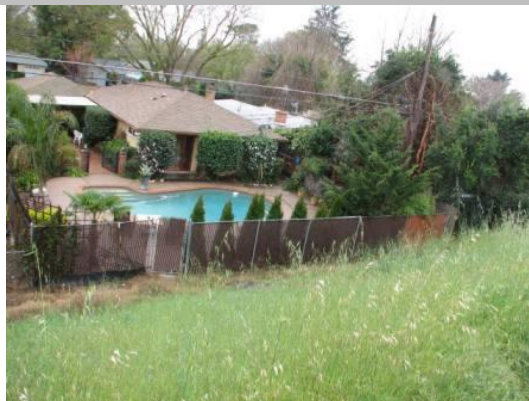
Photo 1 of 1 : SP_2016_NA0001_55_205_20160229_00172.jpg

LM Start	4.83	Rating **	U	Issue No.	205
LM End	4.83	Issue Type +	En	Location *	LS
Category	Earthen Levee			GPS Latitude/Longitude	
				Start	End
Item	Encroachments			38.580723 °	38.580723 °
				-121.432577 °	-121.432577 °
DWR ID	DWR_NA0001_04_s _ 2012_205				
Comment Code					
FE : Fence					
Inspector Comment					
Privacy fence and landscape prunings on levee slope and toe.prunings removed. Fence obstructs access and visibility.

03/16/2012 Chainlink fence with privacy slats obstructs visibility and access.

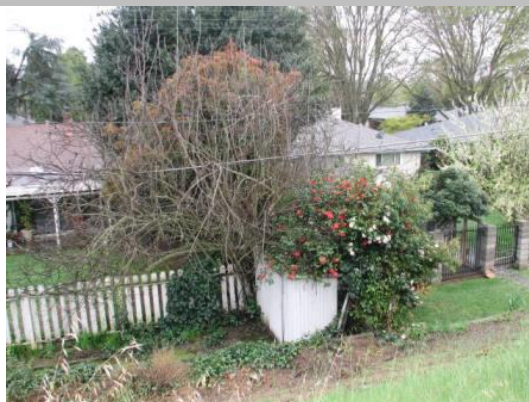
Photo 1 of 1 : SP_2016_NA0001_55_206_20160229_00173.jpg

LM Start	4.87	Rating **	U	Issue No.	206
LM End	4.87	Issue Type +	En	Location *	LS
Category	Earthen Levee			GPS Latitude/Longitude	
				Start	End
Item	Vegetation			38.580778 °	38.580778 °
				-121.431704 °	-121.431704 °
DWR ID	DWR_NA0001_04_s _ 2012_206				
Comment Code					
V6 : Landscaping					
Inspector Comment					
Fig tree obstructs visibility and access.

03/16/2012 Landscaping obstructs visibility and access.

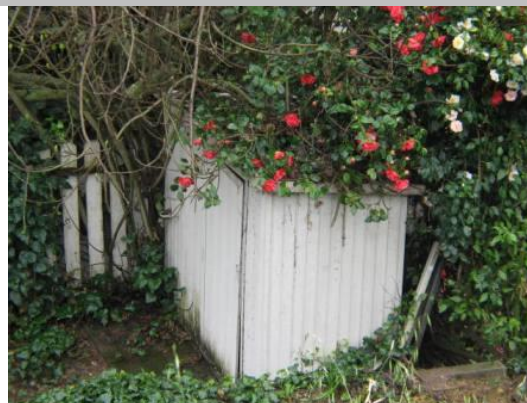
Photo 1 of 1 : SP_2016_NA0001_55_96_20160229_00080.jpg

LM Start	4.87	Rating **	U	Issue No.	96
LM End	4.87	Issue Type +	En	Location *	LS
Category	Earthen Levee			GPS Latitude/Longitude	
				Start	End
Item	Encroachments			38.580767 °	38.580767 °
				-121.431684 °	-121.431684 °
DWR ID	DWR_NA0001_04_s_2012_96				
Comment Code					
BU : Building					
Inspector Comment					
Wooden shed is located beneath the fig tree.

3/16/2012 Structure is within 15' of levee toe.

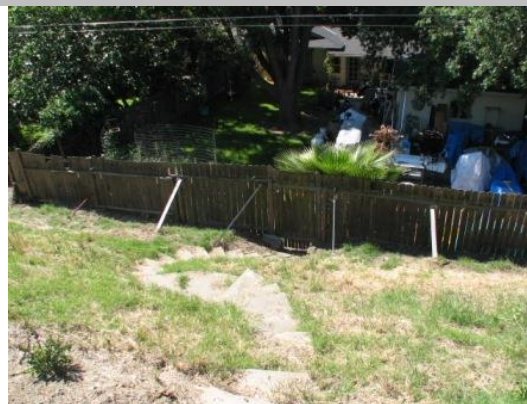
Photo 1 of 1 : SP_2016_NA0001_55_45_20160229_00036.jpg

LM Start	4.93	Rating **	U	Issue No.	45
LM End	4.93	Issue Type +	En	Location *	LS
Category	Earthen Levee			GPS Latitude/Longitude	
				Start	End
Item	Encroachments			38.580846 °	38.580846 °
				-121.430699 °	-121.430699 °
DWR ID	DWR_NA0001_04_s_2012_45				
Comment Code					
FE : Fence					
Inspector Comment					
Wooden fence with bracing obstructs access and visibility.

Wooden fence and braces obstruct access and visibility.

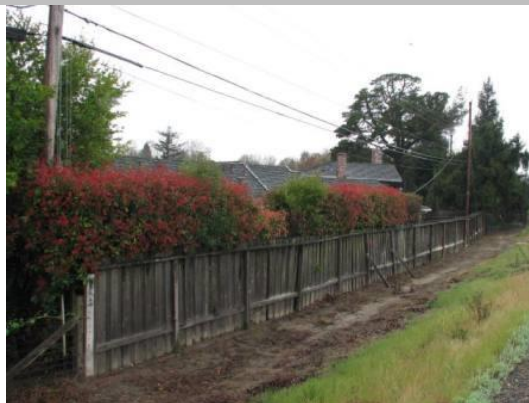
Photo 1 of 1 : SP_2016_NA0001_55_46_20160229_00037.jpg

LM Start	5.08	Rating **	U	Issue No.	46
LM End	5.08	Issue Type +	En	Location *	LS
Category	Earthen Levee			GPS Latitude/Longitude	
				Start	End
Item	Encroachments			38.581001 °	38.581001 °
				-121.427854 °	-121.427854 °
DWR ID	DWR_NA0001_04_s_2012_46				
Comment Code					
FE : Fence					
Inspector Comment					
Privacy fence and landscaping within 10-ft of the levee toe obstruct access and visibility.

03/16/2012 Wood privacy fence completely obstructs access and visibility.

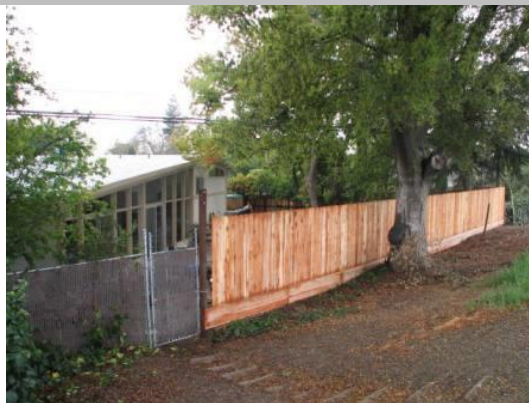
Photo 1 of 1 : SP_2016_NA0001_55_208_20160229_00174.jpg

LM Start	5.12	Rating **	U	Issue No.	208
LM End	5.12	Issue Type +	En	Location *	LS
Category	Earthen Levee			GPS Latitude/Longitude	
				Start	End
Item	Encroachments			38.580913 °	38.580913 °
				-121.427119 °	-121.427119 °
DWR ID	DWR_NA0001_04_s_2012_208				
Comment Code					
FE : Fence					
Inspector Comment					
Privacy fence and landscaping within 10-ft of the levee toe obstruct access and visibility.

03/16/2012 Wood privacy fence completely obstructs access and visibility.

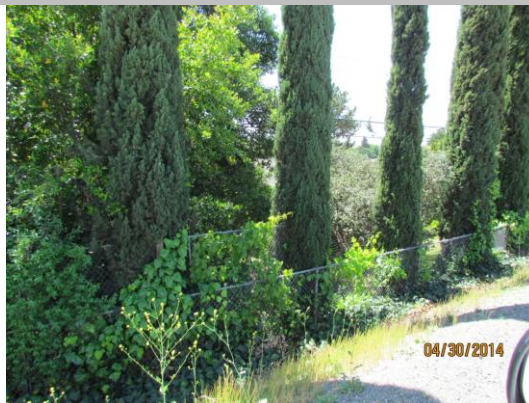
Photo 1 of 1 : SP_2016_NA0001_55_47_20160229_00038.jpg

LM Start	5.15	Rating **	M	Issue No.	47
LM End	5.15	Issue Type +	En	Location *	LS
Category	Earthen Levee			GPS Latitude/Longitude	
				Start	End
Item	Encroachments			38.580773 °	38.580773 °
				-121.426691 °	-121.426691 °
DWR ID	DWR_NA0001_04_s _ 2012_47				
Comment Code					
FE : Fence					
Inspector Comment					
Chain link fence, helix sky pencil, and landscaping within 10-ft of the levee toe obstruct access and visibility.

View of the fence and vegetation at the landside levee toe.

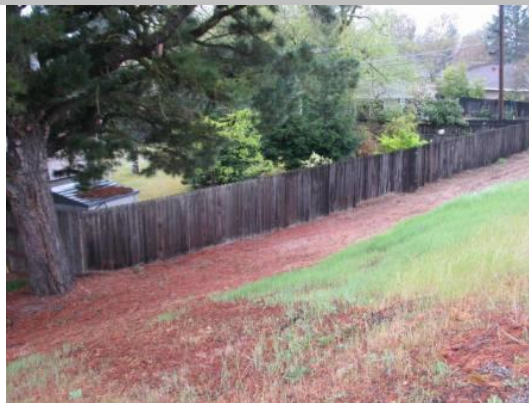
Photo 1 of 1 : SP_2016_NA0001_55_49_20160229_00040.jpg

LM Start	5.44	Rating **	U	Issue No.	49
LM End	5.44	Issue Type +	En	Location *	LS
Category	Earthen Levee			GPS Latitude/Longitude	
				Start	End
Item	Encroachments			38.577589 °	38.577589 °
				-121.423350 °	-121.423350 °
DWR ID	DWR_NA0001_04_s _ 2012_49				
Comment Code					
FE : Fence					
Inspector Comment					
Wood privacy fence within 10-ft of the levee toe obstruct access and visibility.

03/16/2012 Wood privacy fence completely obstructs access and visibility.

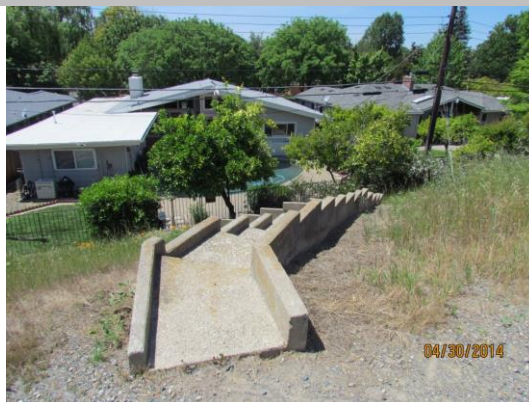
Photo 1 of 1 : SP_2016_NA0001_55_197_20160229_00167.jpg

LM Start	5.56	Rating **	U	Issue No.	197
LM End	5.56	Issue Type +	En	Location *	LS
Category	Earthen Levee			GPS Latitude/Longitude	
				Start	End
Item	Encroachments			38.575887 °	38.575887 °
				-121.423113 °	-121.423113 °
DWR ID	DWR_NA0001_04_s _ 2013_197				
Comment Code					
ST : Stairway					
Inspector Comment					
Unpermitted stairs to be removed by ARFCD.

View of the stairs on the landside levee slope.

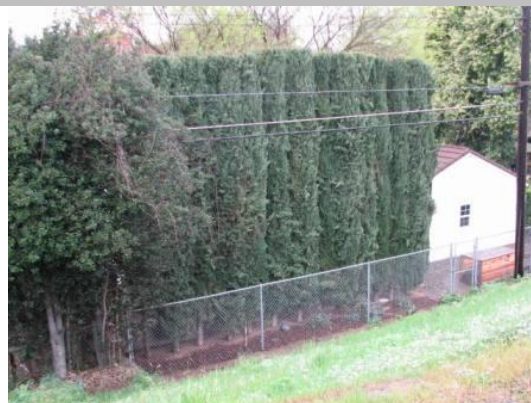
Photo 1 of 1 : SP_2016_NA0001_55_52_20160229_00042.jpg

LM Start	5.60	Rating **	U	Issue No.	52
LM End	5.60	Issue Type +	En	Location *	LS
Category	Earthen Levee			GPS Latitude/Longitude	
				Start	End
Item	Vegetation			38.575379 °	38.575379 °
				-121.423201 °	-121.423201 °
DWR ID	DWR_NA0001_04_s_2012_52				
Comment Code					
V6 : Landscaping					
Inspector Comment					
Helix sky pencil trees within 10-ft of the levee toe obstruct visibility and access.

03/16/2012 Landscaping obstructs visibility and access.

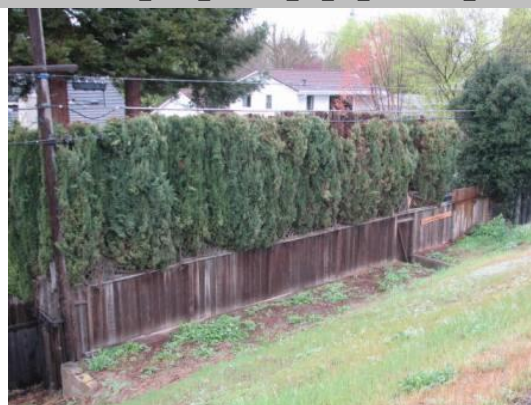
Photo 1 of 1 : SP_2016_NA0001_55_53_20160229_00043.jpg

LM Start	5.61	Rating **	U	Issue No.	53
LM End	5.61	Issue Type +	En	Location *	LS
Category	Earthen Levee			GPS Latitude/Longitude	
				Start	End
Item	Vegetation			38.575250 °	38.575250 °
				-121.423240 °	-121.423240 °
DWR ID	DWR_NA0001_04_s_2012_53				
Comment Code					
V6 : Landscaping					
Inspector Comment					
Wood privacy fence, helix sky pencil, vines and landscaping within 10-ft of the levee toe obstruct access and visibility. Cement stairs up levee slope.

03/16/2012 Landscaping and fence obstruct visibility and access.

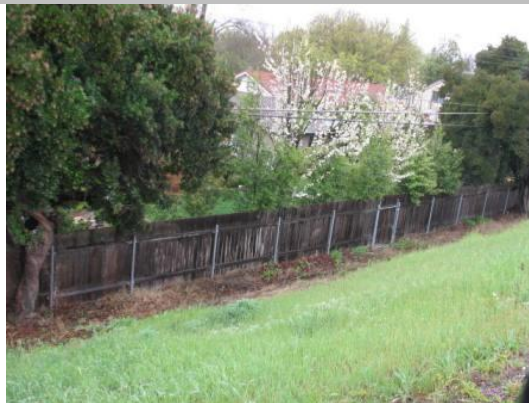
Photo 1 of 1 : SP_2016_NA0001_55_55_20160229_00045.jpg

LM Start	5.63	Rating **	U	Issue No.	55
LM End	5.63	Issue Type +	En	Location *	LS
Category	Earthen Levee			GPS Latitude/Longitude	
				Start	End
Item	Encroachments			38.574837 °	38.574837 °
				-121.423297 °	-121.423297 °
DWR ID	DWR_NA0001_04_s _ 2012_55				
Comment Code					
FE : Fence					
Inspector Comment					
Wood privacy fence within 10-ft of the levee toe obstructs visibility.

03/16/2012 Wood privacy fence completely obstructs access and visibility.

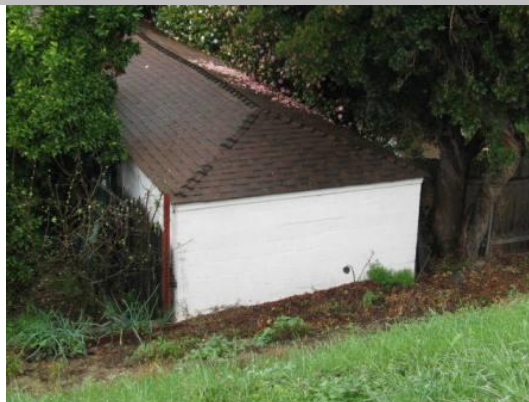
Photo 1 of 1 : SP_2016_NA0001_55_56_20160229_00046.jpg

LM Start	5.65	Rating **	U	Issue No.	56
LM End	5.65	Issue Type +	En	Location *	LS
Category	Earthen Levee			GPS Latitude/Longitude	
				Start	End
Item	Encroachments			38.574648 °	38.574648 °
				-121.423348 °	-121.423348 °
DWR ID	DWR_NA0001_04_s _ 2012_56				
Comment Code					
BU : Building					
Inspector Comment					
Cement block building on levee slope obstructs access.

03/16/2012 Structure within 15' of levee toe.

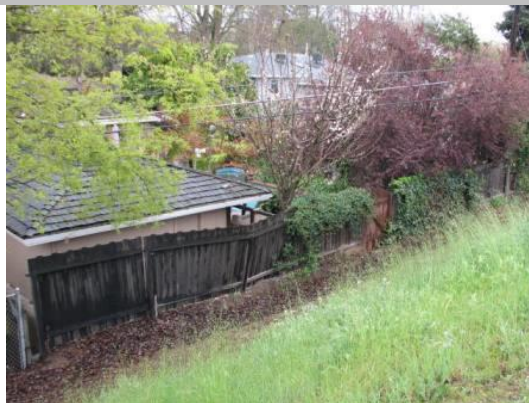
Photo 1 of 1 : SP_2016_NA0001_55_57_20160229_00047.jpg

LM Start	5.70	Rating **	U	Issue No.	57
LM End	5.70	Issue Type +	En	Location *	LS
Category	Earthen Levee			GPS Latitude/Longitude	
				Start	End
Item	Encroachments			38.573927 °	38.573927 °
				-121.423480 °	-121.423480 °
DWR ID	DWR_NA0001_04_s _ 2012_57				
Comment Code					
FE : Fence					
Inspector Comment					
Wood privacy fence with ivy obstructs visibility.

03/16/2012 Wood privacy fence completely obstructs access and visibility.

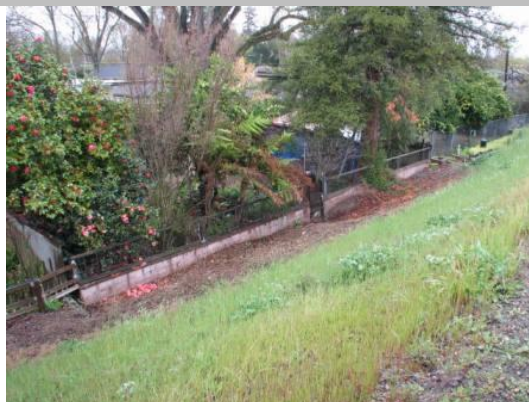
Photo 1 of 1 : SP_2016_NA0001_55_59_20160229_00048.jpg

LM Start	5.73	Rating **	U	Issue No.	59
LM End	5.73	Issue Type +	En	Location *	LS
Category	Earthen Levee			GPS Latitude/Longitude	
				Start	End
Item	Encroachments			38.573403 °	38.573403 °
				-121.423642 °	-121.423642 °
DWR ID	DWR_NA0001_04_s _ 2012_59				
Comment Code					
FE : Fence					
Inspector Comment					
Brick fence and landscaping within 10-ft of the levee toe obstructs access and visibility.

03/16/2012 Fence and landscaping obstruct visibility and access.
